FIELD REFERENCE MANUAL

SUBMERSIBLE MOTORS

This Field Reference Manual includes examples of some of the limitations presented in the Franklin Electric Standard Limited Warranty Policy.

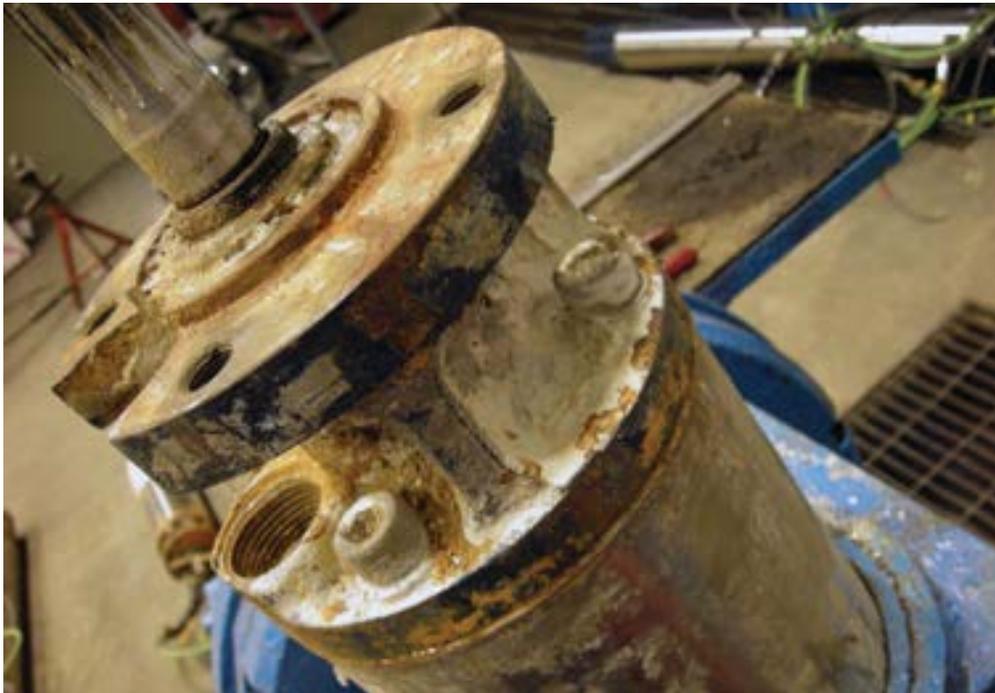
No Lead Installed - Sediment
Not Warrantable

Corrosion Damage
Refer to Next Page

Corrosion/Scale
Not Warrantable

Excessive Corrosion
Not Warrantable

No Lead - Corrosion
Not Warrantable

To qualify for warranty, the motor must be evaluated with its original factory installed components. This includes the original factory installed lead assembly. Excessive sediment and/or corrosion may indicate the motor did not see proper cooling flow and the pumping media may be aggressive. Review 316SS motor construction as an alternative for added corrosion resistance. Water quality analysis may be required for proper motor construction determination.

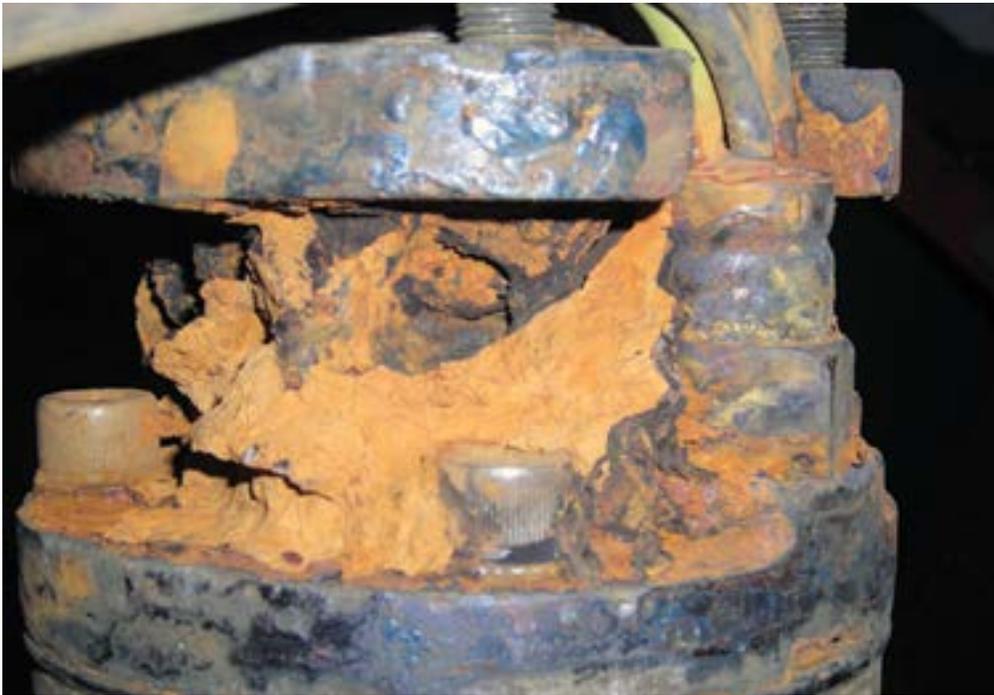
Aggressive Environment Causes Corrosion

This example is a result of corrosion damage caused by an aggressive environment. Corrosion caused damage in the lead connection area, shown bottom right, which allowed water entry resulting in the motor grounding. This motor is not warrantable. The added corrosion resistance of the 316SS motor construction may be needed in the application.

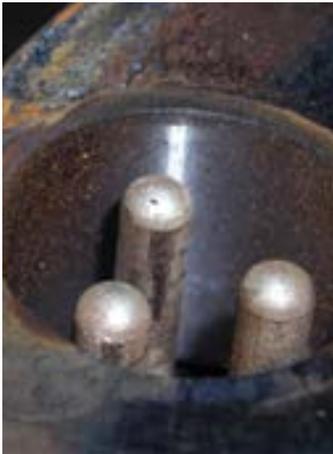
Corrosion and Rust in Prong Hole

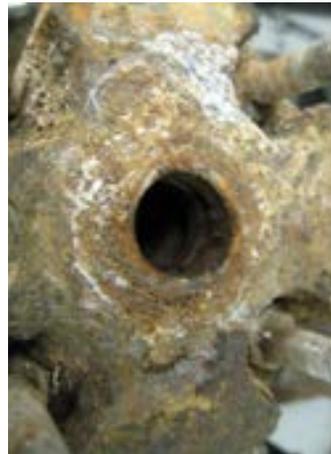
Corrosion in Lead Area

Excess Corrosion/Scale

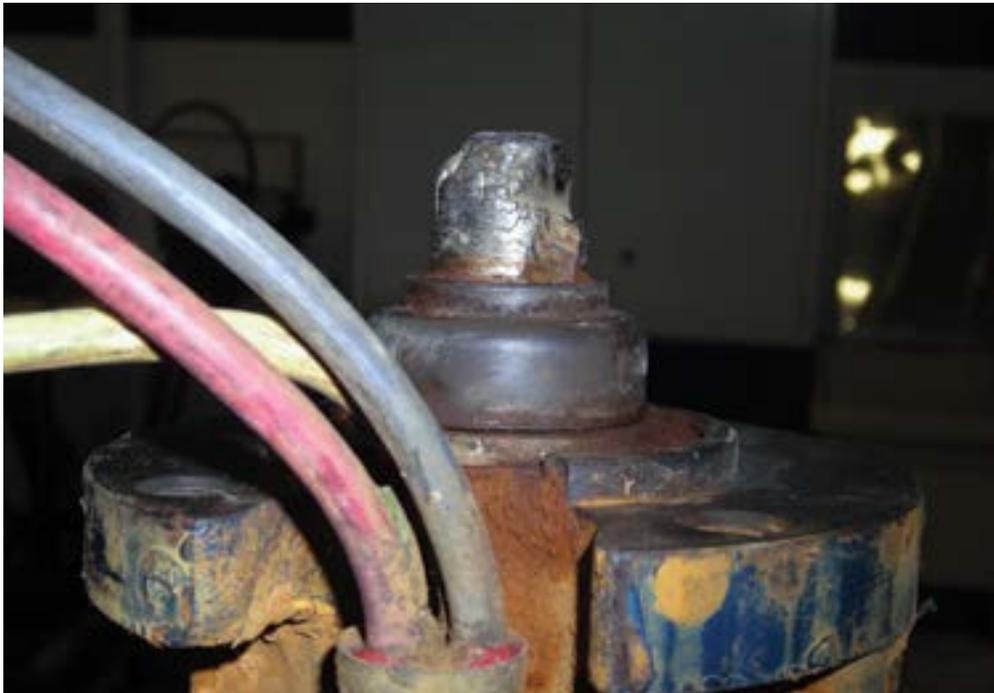
Shaft Broken by Excessive Torque (Ex: Back-Spinning Pump During Pump Start)

Motor Shaft Damaged by Gravel in the Pump Intake
Not Warrantable

Shaft Damaged Below Spline by Improper Coupling Installation
Not Warrantable

Debris in Bearing
Shaft Damage

Up Thrust
Not Warrantable

Damage to the shaft by pumping media, improper coupling, and/or pump installation is not covered under warranty.

Refer to "Use of Check Valves" in the Franklin Electric Application, Installation, Maintenance (AIM) Manual.

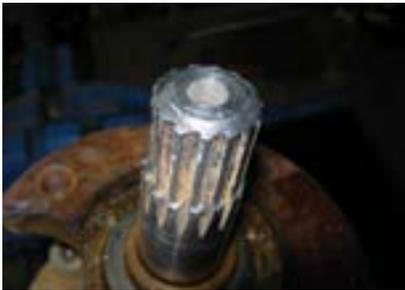
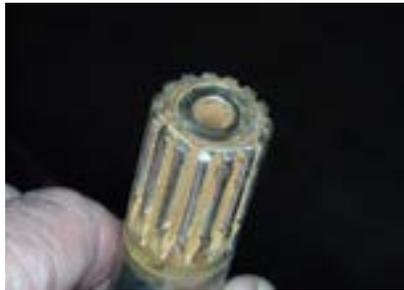
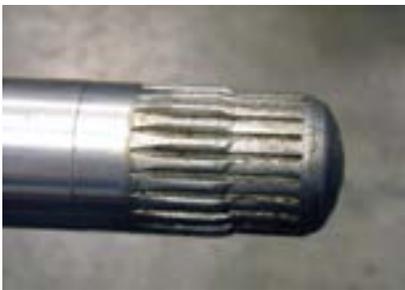
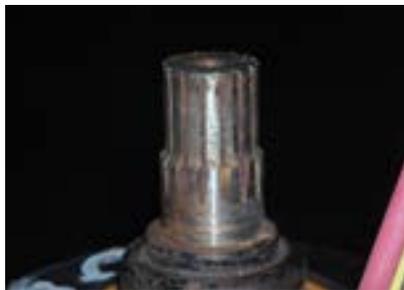
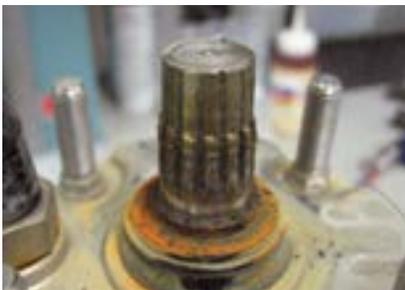
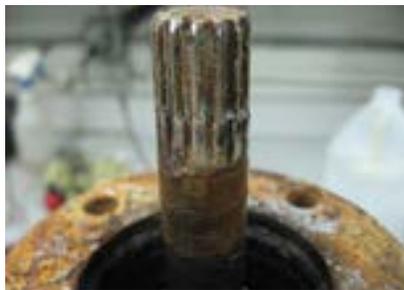
Threaded Hole in Shaft

All photos are examples of non-warrantable motors.

Damaged splines are not considered defects in material or workmanship and therefore are not covered under warranty. Splines can be damaged by improper installation of pump and/or pump coupling.

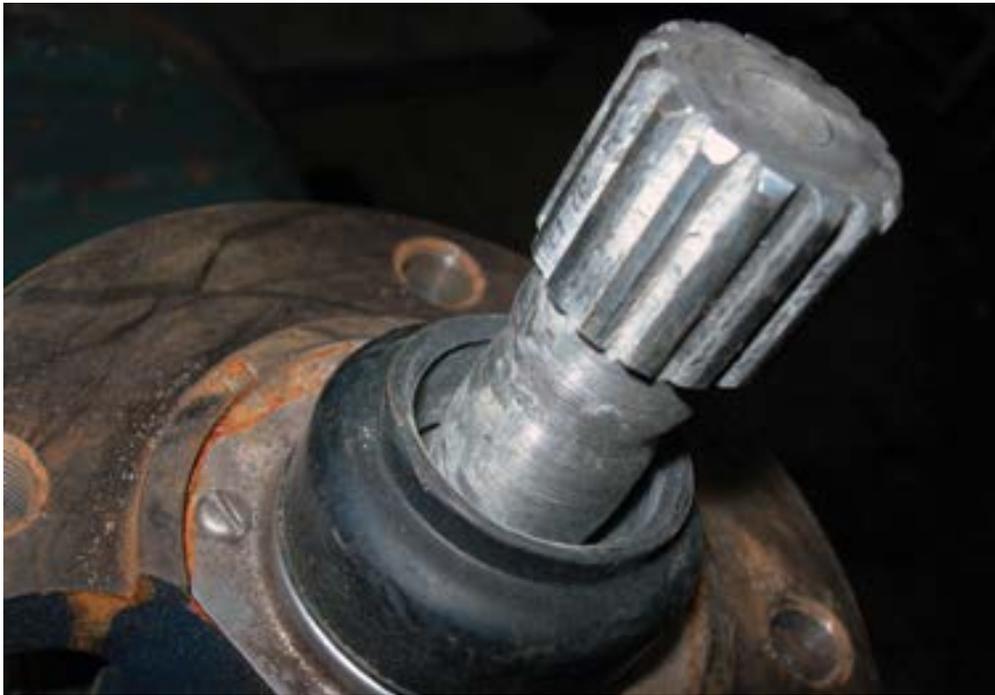
Abrasive Damage is Not Covered Under Warranty

Abrasive Worn Shaft End

Spline Wear by Abrasives

Abrasive Shaft Wear

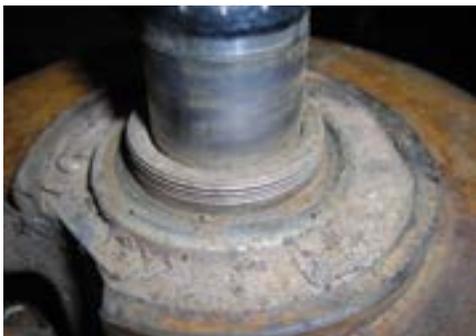
External Abrasives

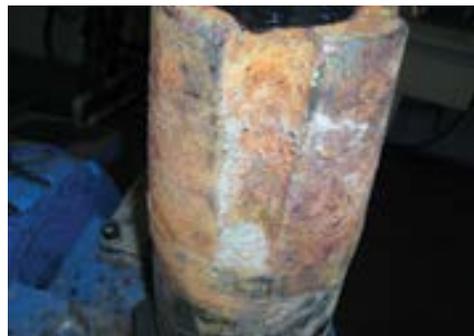
Sand Found On Components

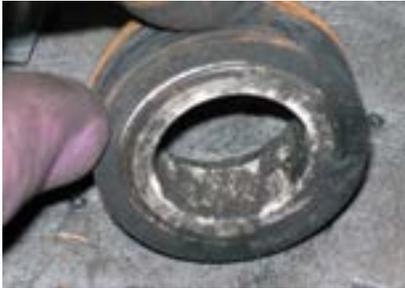
Abrasive Covered Seal/Worn ID
Not Visible

This is an example of the damage caused by abrasive entry. Abrasives damage the shaft's shaft seal and shaft slinger brass bushing, allowing damage to the bearings and stator bore including liner. In most cases, the sand slinger will be loose on the shaft.

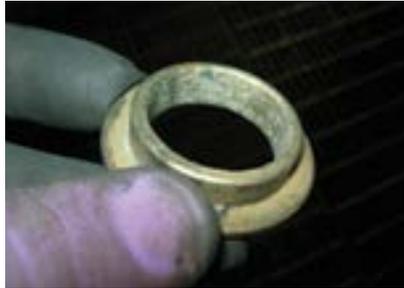
Worn Shaft Slinger Bushing ID
Not Visible

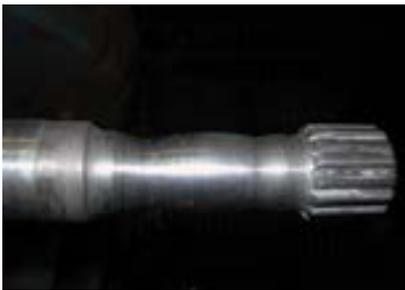
Severely Worn Shaft
Visible

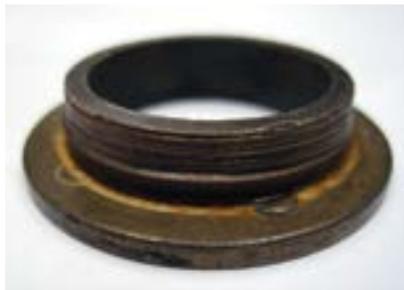
Sand Worn Shaft Slinger Bushing
Visible

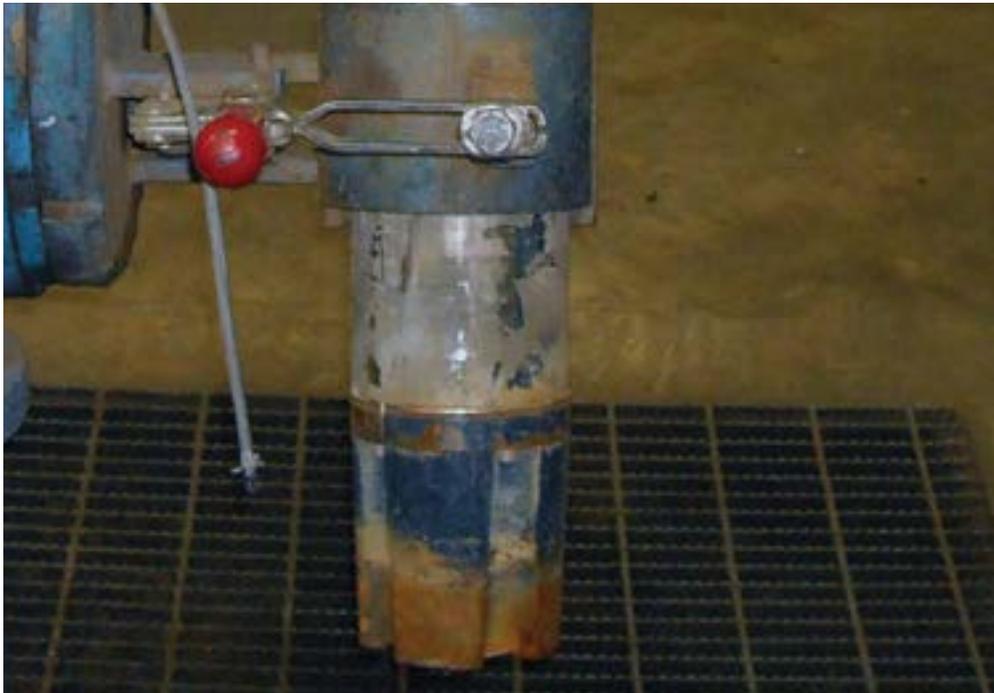
Example of Diaphragm Cavity When Motor is Buried

Rust In Diaphragm Well Rusty

Diaphragm Cavity Full of Mud Motor Shown Above

Buried at Bottom of Well

Aggressive/Sandy Water or Motor in Sand

Diaphragm Cover Full of Mud

These photos document example installations that did not have 10 feet of clear water between the motor bottom and the bottom of the well. This will cause lack of flow by the thrust housing, creating a "hot spot" and damaging the bearings in the lower half of the motor. The diaphragm cavity can be checked through the hole in the plate/cover, or by removing bottom cover.

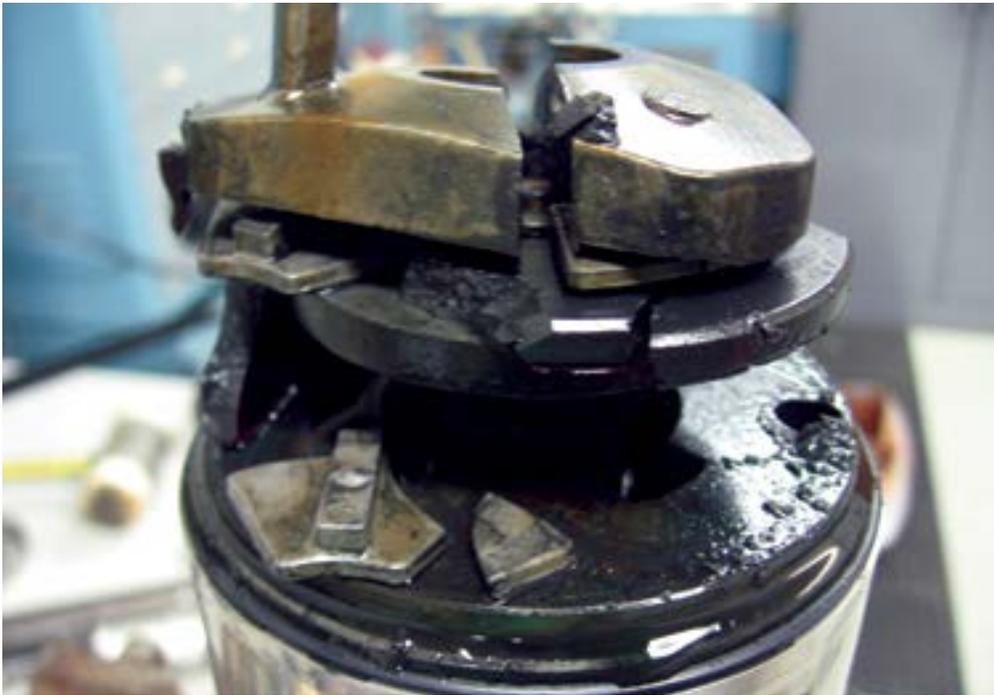
Broken Thrust Bearing, Support, And Thrust Pads

Extreme Shock Required to Fracture/Split Bearings

Dimples From Water Hammer

Improper Cooling and Thrust Loads
Over Rated Capabilities

These photos document examples of water hammer damage to the thrust bearing system.

This damage is caused by rapid or failed check valve issues. The shock load associated with water hammer is generally well in excess of the rated thrust load.
