FIELD REFERENCE MANUAL

SUBMERSIBLE MOTORS

This Field Reference Manual includes examples of some of the limitations presented in the Franklin Electric Standard Limited Warranty Policy.

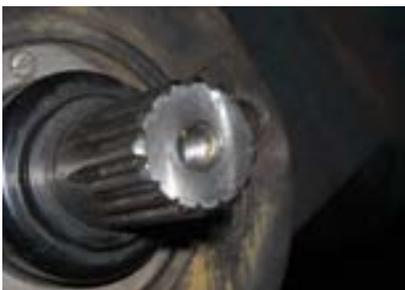
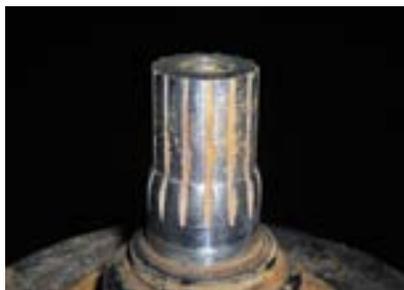
Threaded Hole in Shaft

All photos are examples of non-warrantable motors.

Damaged splines are not considered defects in material or workmanship and therefore are not covered under warranty. Splines can be damaged by improper installation of pump and/or pump coupling.

Any alteration of the shaft or splines outside Franklin Electric factory specifications voids warranty.
